# Siasconset Beach Preservation Fund

## Summer 2015 Community Update

## Geotubes succeed for second winter

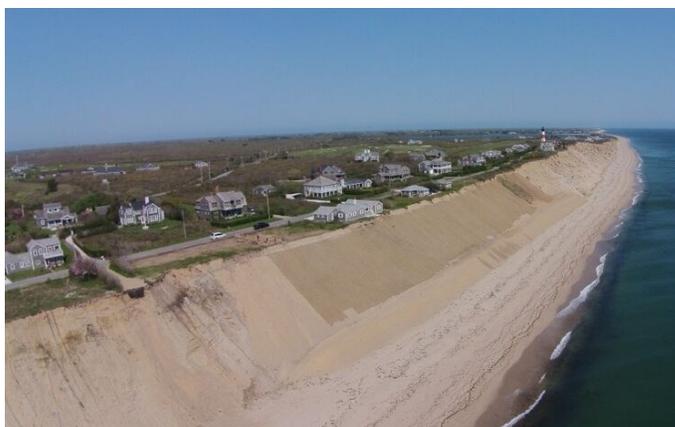
*Geotubes are effectively protecting "Sconset Beach from erosion.*

There has been no erosion from the toe of the Bluff since the geotubes were installed in late 2013.

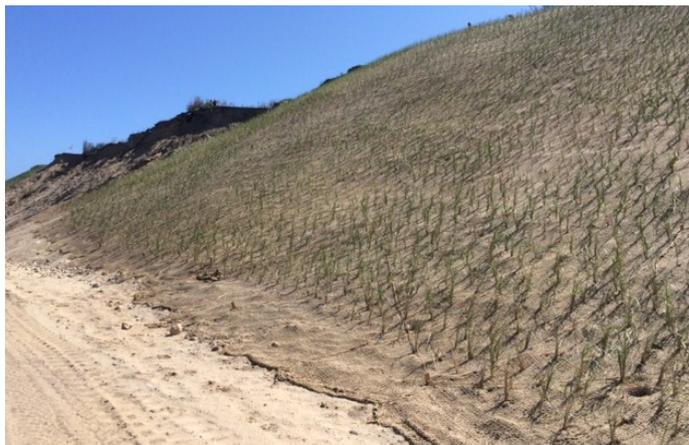
*Newly vegetated bluff will limit runoff impact.*

While we are only allowed to plant in areas behind the 900 feet geotube project, that work has been completed and you can already see the vegetation. As the new beach grass grows out fully over the next few years it will both blend in seamlessly and stabilize the bluff with an extensive root system.

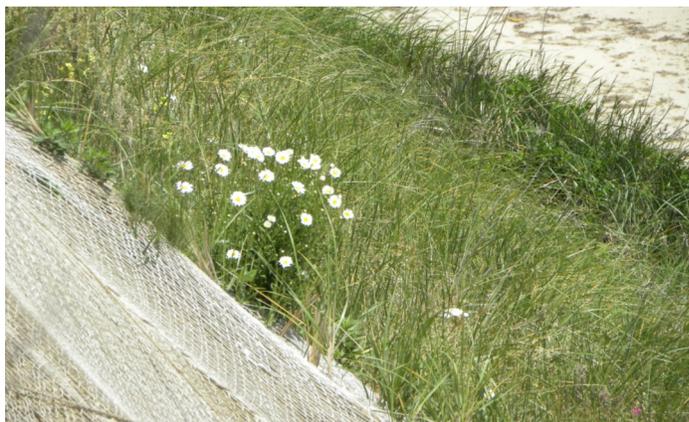
*The fully vegetated bluff will be both beautiful and functional.*

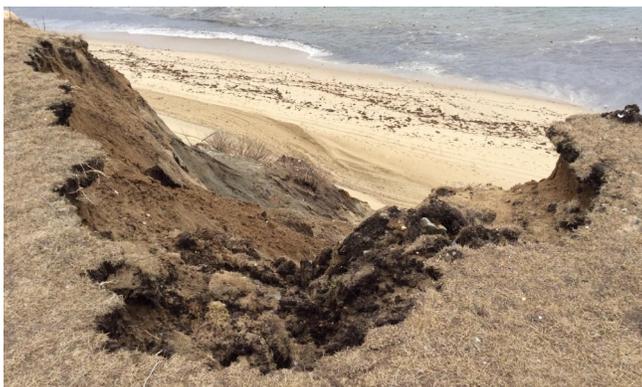
*Storm water runoff impacting the bluff. This can be fixed!*

It is also important to address runoff from rainstorms that flow from Baxter Road over the bluff. There are several approaches to moving forward: installing a drainpipe buried in the newly restored bluff to carry rain water down to a dry well at the back of the geotubes; or creating a more elaborate storm water infiltration system within the Baxter Road right of way, which SPBF designed and the Conservation Commission actually approved this winter. A berm along the ocean side of Baxter has been installed as part of the permitted system and is now in place preventing runoff from going over the bluff.

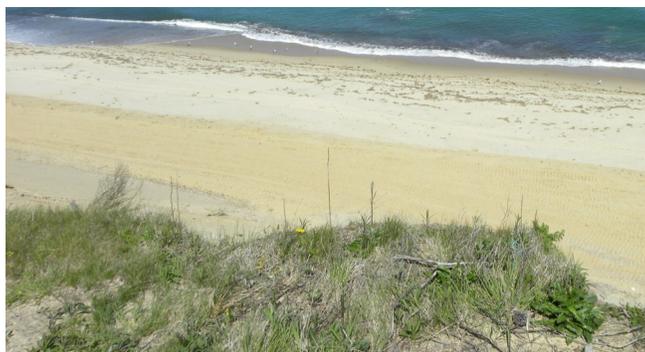
*Geotubes (nearly invisible under sand cover) have never impacted normal access to 'Sconset Beach and Bluff.*

- ⇒ Sand-filled sleeves of geotextile fabric, like very big sausages.
- ⇒ The ones in this project are approximately 7 feet tall and 19 feet across with a circumference of 45 feet.
- ⇒ They are approximately 100-200 feet long.
- ⇒ They rest on a fabric scour apron with sand-filled anchor tubes along the sea-ward edge of the bottom tube and the landward edge of the top tube.
- ⇒ Geotubes are typically placed parallel to shore along the back beach, with sand and natural vegetation cover.

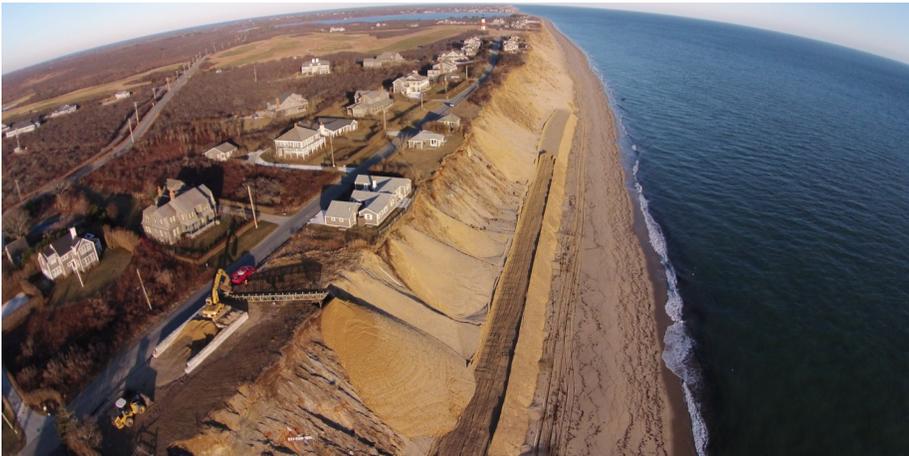
Twice annual deliveries of sand in the off season assure that adjacent beaches are not impacted.

The sand is delivered from mid-island sand pits during the off season, with delivery concentrated into compact time periods—one week in late fall/early winter and one week in early spring.

- ⇒ 150% of sand that erodes naturally was replenished.
- ⇒ 1900 cubic yards was delivered
- ⇒ 28,500 tons of sand total
- ⇒ Truck deliveries over 10 days, all off season
