From January 30, 2015 Inquirer and Mirror

Geotubes do their job against Juno

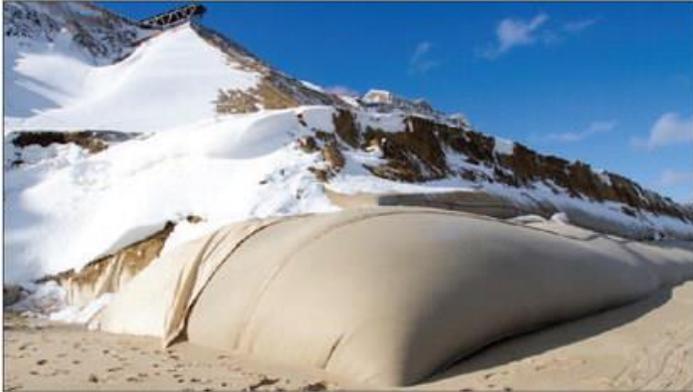
On Wednesday afternoon, the top two tiers at the southern end of the system could be seen, but, further north, all three bags were exposed.

"This is the first time the third tier has been exposed since the system was installed," Posner said. "We've had the second tier exposed and we've had some places where the third tier has been exposed, but this is the first time it's gone all the way up to the top of the third tier."

Exposed geotubes after the historic blizzard Wednesday protected the toe of Sconset Bluff.

Sand, which was delivered to the system beginning on Jan. 16, will be pushed from the top bag and down over the exposed geotubes to cover the face again, Posner said. That reserve sand is kept there for these kinds of situations, he added.
