2016 COMMUNITY UPDATE

News from the Bluff

Monitoring the Bluff Protection Project

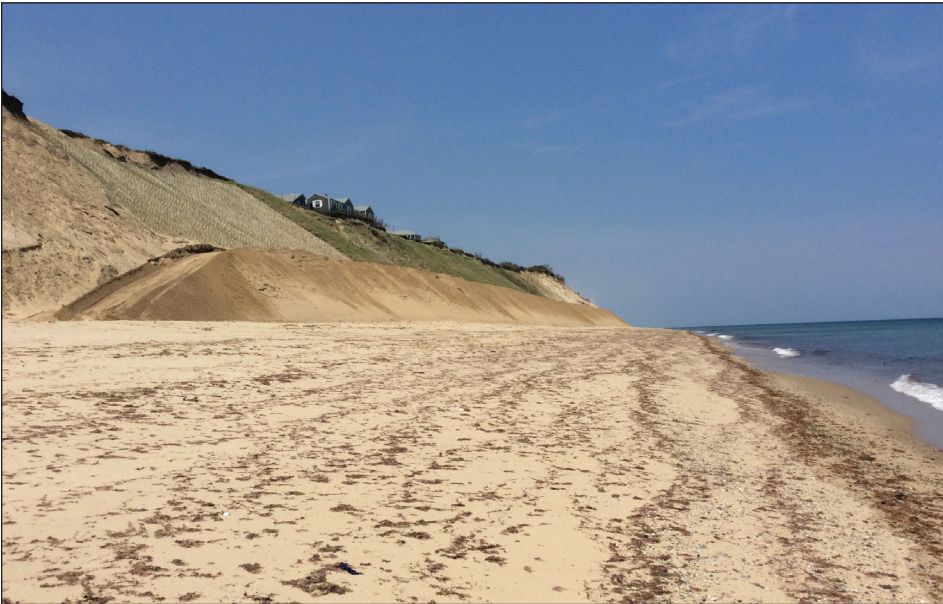
Sand-covered geotubes protect the toe of the bluff. Newly planted vegetation (foreground) and one-year-old vegetation (background) stabilize the face of the bluff. May 2016

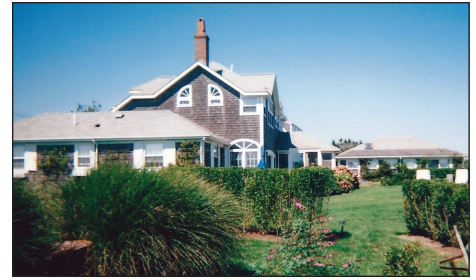
TOP: The McQuades house on 97 Baxter Road before a series of winter superstorms eroded more than 30 feet in one year. Overall the family lost more than 100 feet of property before the house was eventually cut up into five pieces and moved to another location on island.

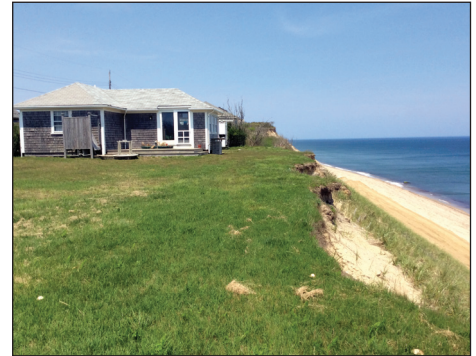
ABOVE: After their home was cut into five sections to be moved, the McQuades joined together two of the older sections to form this 700 sq. ft. cottage that is still in use on their property. The geotubes are protecting the most vulnerable section of the bluff, yet, if the project were expanded beyond the emergency measure, it could prevent further loss of property and potentially save 20 more homes along Baxter Road.

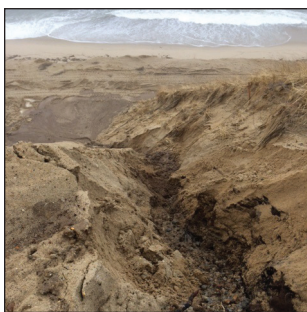
ABOVE LEFT: This photo clearly illustrates the need for the drainage system that was installed near the Observation Area this winter. Runoff coming down Baxter Road created a gully on the face of the bluff contributing to its erosion.

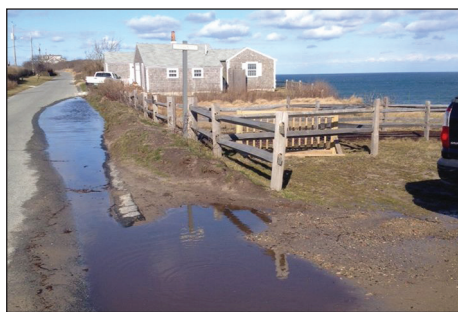
ABOVE MIDDLE: Runoff was pooling along the roadway. This section of Baxter Road, closest to the edge of the bluff, is critical to maintain access to homes north of the area and Sankaty Lighthouse.

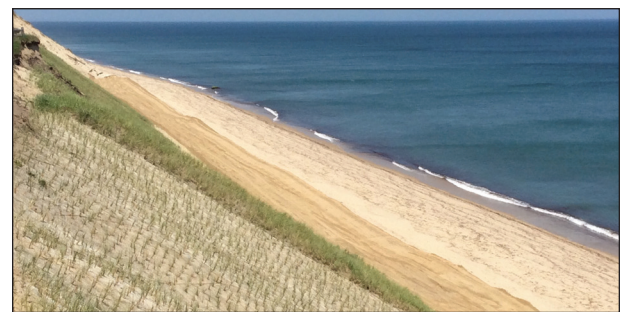
ABOVE RIGHT: Newly planted and more mature vegetation on the face of the bluff help stabilize it, while the sand-covered geotubes (darker sand) protect the toe from erosion.

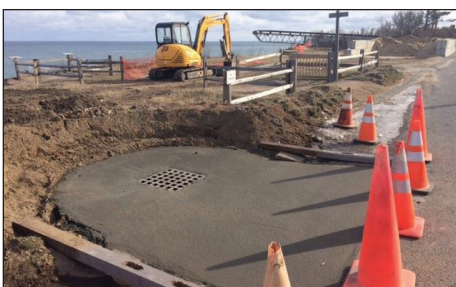
LEFT: Now that the geotubes are protecting the toe of the bluff, the catch basin and drainage system on Baxter Road are helping with run off and erosion from the top of the bluff.

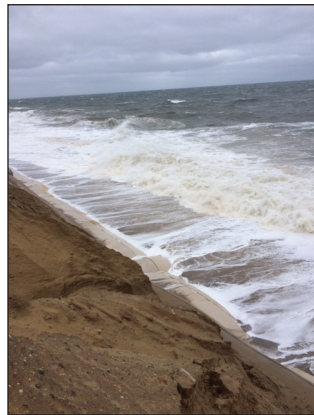
BELOW: The geotubes are doing their job. The waves crash against the toe, exposing parts of the sand-covered geotubes.

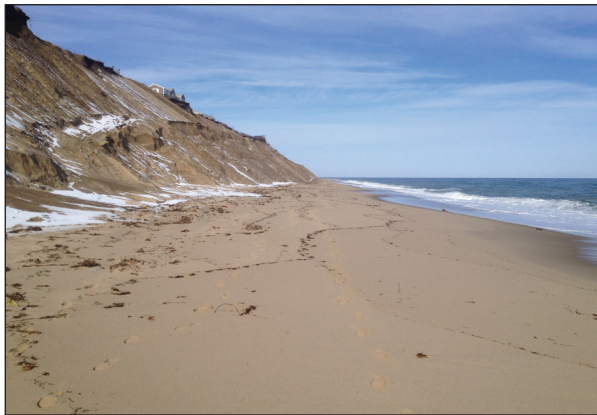
BELOW RIGHT: After the storm, the geotubes were covered with sand stored at the top of the template.
