2017 COMMUNITY UPDATE

After 4th Winter; Geotubes Still Working Great

Erosion Protection Project Mimics Mother Nature

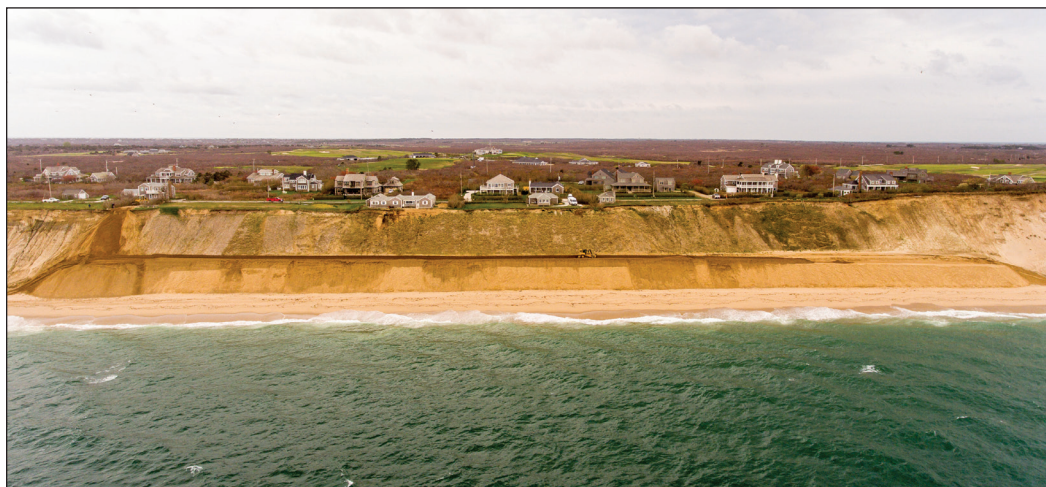
Geotubes covered by a sand template currently protect Baxter Road and homes along 950 feet of shoreline.

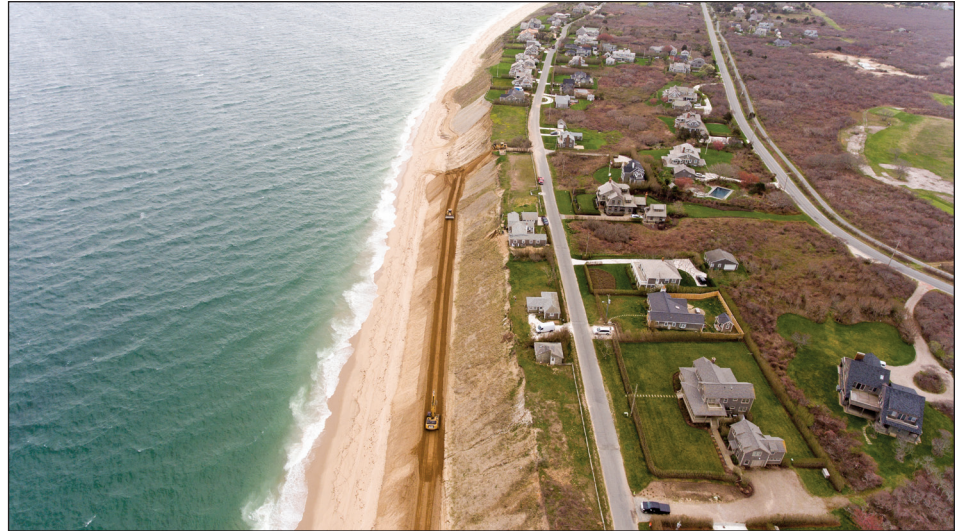
TOP: Aerial photo shows how close Baxter Road is to the edge of the Bluff

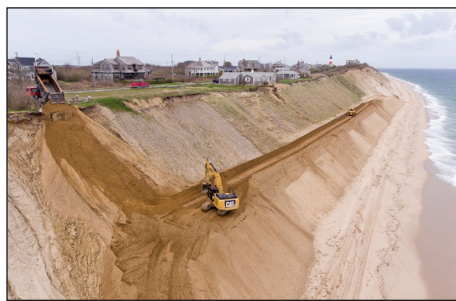
ABOVE LEFT: Mitigation sand is poured over the Bluff and spread along the sand template in the off-season

This mitigation sand, about 1,000 truckloads, is excavated from on-island pits and trucked to the site in the off-season. The sacrificial sand that covers the geotubes is designed to wash away during storm events, partially uncovering the geotubes, in a similar manner to bluff erosion where there is no protection.

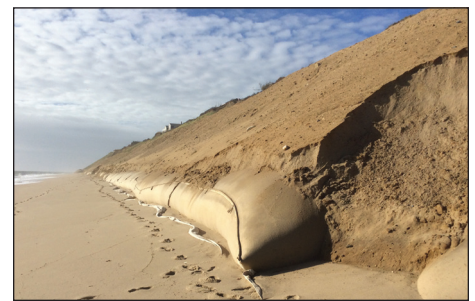
ABOVE RIGHT: Geotubes become partially uncovered after a major storm as designed. Sand will be pulled down from the template, covering the geotubes again.

Instead of the high energy waves hitting and eroding sand from the bluff, the waves crash against the sand-covered geotubes that extend 40 feet seaward from the bluff’s base and wash away part of the geotube’s sand cover. After major storms, sand is then pulled down from the top of the template, covering the geotubes again and getting ready for the next storm.
