Siasconset Beach Preservation Fund Update to the Community

Summer 2014

Winter 2013-14: Installing Geotubes to Protect the Bluff and Baxter Road

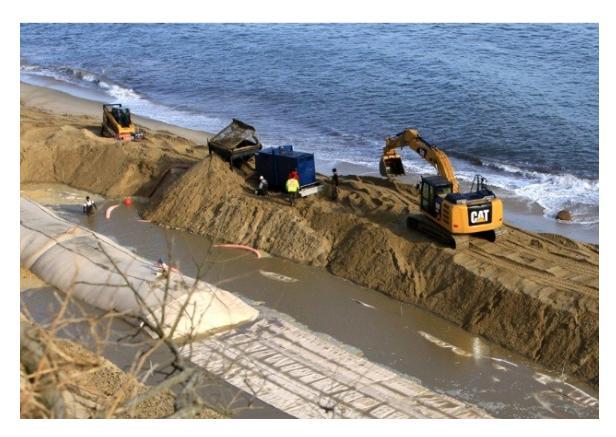
Installation of geotubes took place during a 35 day period between December 2013 and January 2014. The project benefits from significant sand cover over the tubes (volume calculated at 1.5 times the rate of typical erosion) to limit impact on nearby beaches.

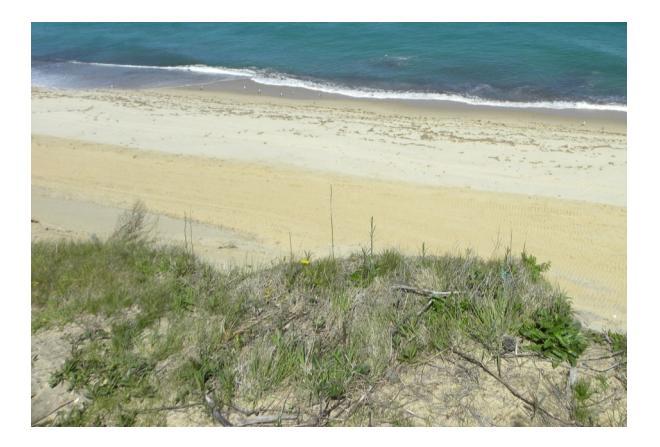
Completed geotube project with sand cover blends into bluff. The geotubes performed well during both a late winter blizzard and July tropical storm, with limited new erosion.

In March, a severe late winter Nor'easter storm and blizzard hit Nantucket; the geotubes performed as expected with some loss of sand template (as designed) and no erosion at toe of the bluff. Some face erosion above the geotubes continues, but that is largely related to runoff from Baxter Road.

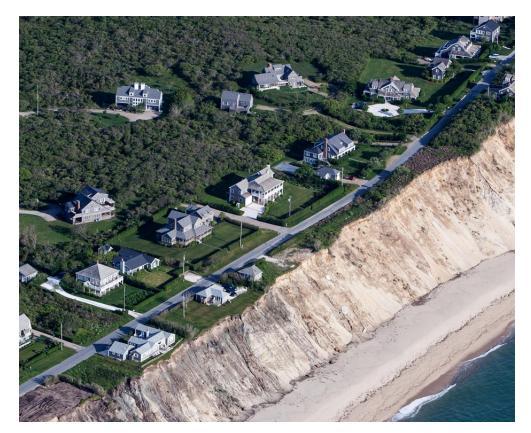
Bluff today; note the proximity of the eroded Bluff to homes and Baxter Road. Should the road be relocated, direct access to Sankaty Light would be threatened.

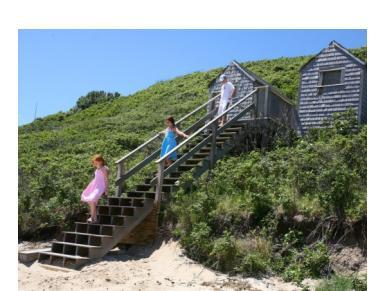
Bluff pre-erosion (2006 photo); today, nearly half of the bluff is bare and eroded
