July 5, 2014

We wanted to update you on how the Sconset erosion project performed during Arthur last night. The system worked well in the face of 50+ MPH winds shifting from SE to NW over the most intense hours, preventing any undermining of the toe of the bluff. There was no scour either in front of the sand covered geotubes or on the ends was caused by the storm driven waves. Once again Baxter Road has been protected. Access to homes and the lighthouse is intact. Winds peaked at over 50 MPH at about 11PM-1AM as its direction shifted from the SE to NW through the night as the storm passed the island.

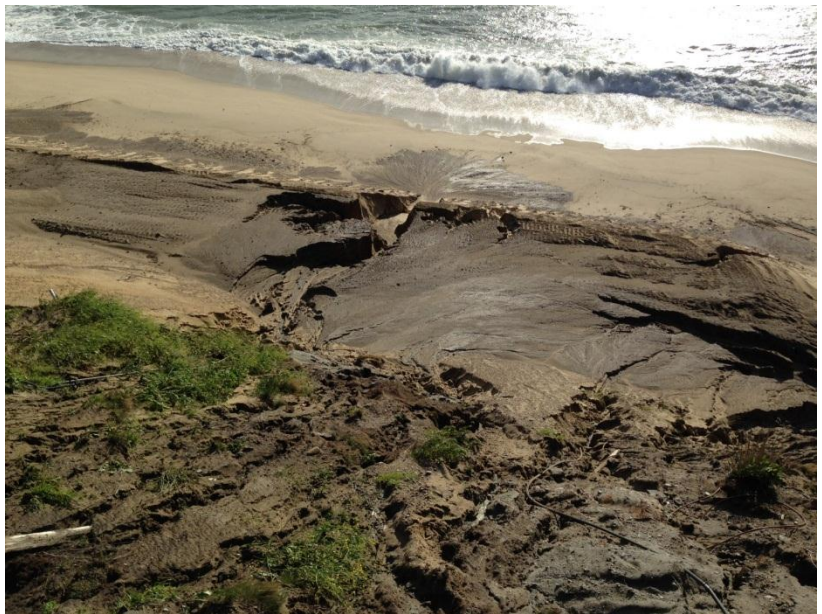
So while the challenging problem of erosion from ocean waves has once been controlled once again, runoff from under 2 inches of rain caused substantial impact to the face of the bluff and the sand template covering the geotubes. Road runoff carried down the hill from the lighthouse flows over the un-vegetated bluff causing large gullies (see photo at right). These fissures in the sand cover will be repaired over the next few days by moving the sand around with a skid steer. Dealing with surface run-off to prevent this unnecessary garden variety erosion from storm water has got to be a priority now.
